## ToolboxTalk

### Cable Chamber Rebuild Arc Prevention

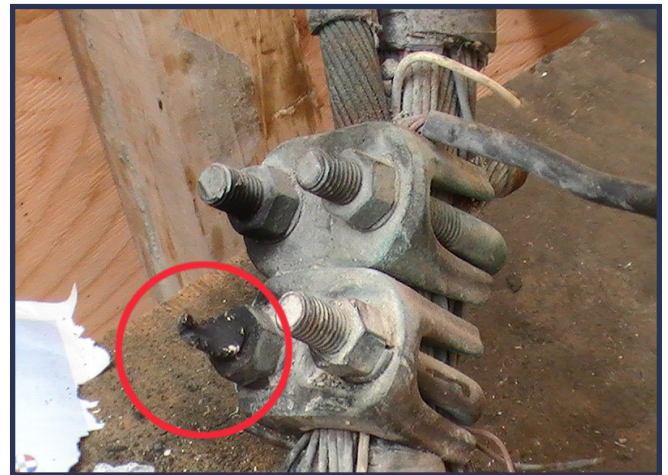
A 240 V cable arced to a bare ground inside a tied up bundle of secondary cables inside a rebuild cable chamber. There were two utility contractor's crew members placing the concrete form for the wall where the cable eventually arced. Fortunately there were no injuries as a result of the arc flash, possibly because the closest workers were behind the concrete form wall.

The damage

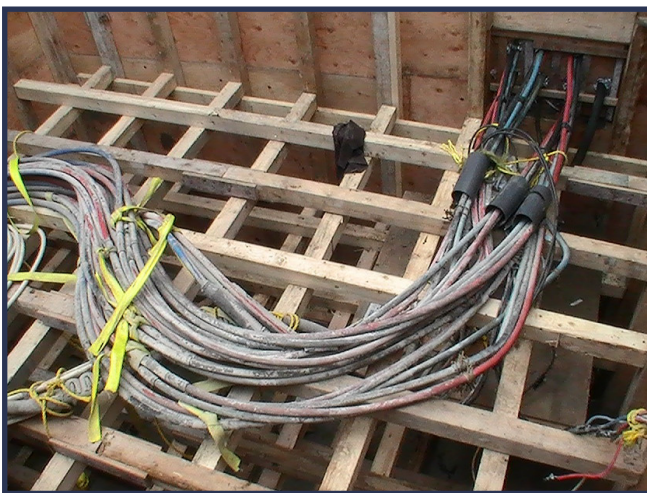
The cables were tied up allowing the upward facing bolts to rub on the insulation of the cables that were tied in the bundle. The vibration from the work taking place in the cable chamber and the traffic next to the chamber allowed the threads of the bolts to rub through the cable insulation.

The cables were tied in a bundle.

The crew members were fortunate that they were not working on the recess pictured at the time of the arc flash. If contractor's workers are on site when the utility secures the cables, they need to ensure that the grounds are secured separate from the cables and that the hardware is protected from damaging cables tied up next to them. If these ground clamps are noticed inside existing bundles of tied cables, contact the utility inspector to arrange for one of their crews to secure the ground separately from the bundle and protect the sharp edges from damaging adjacent cables.

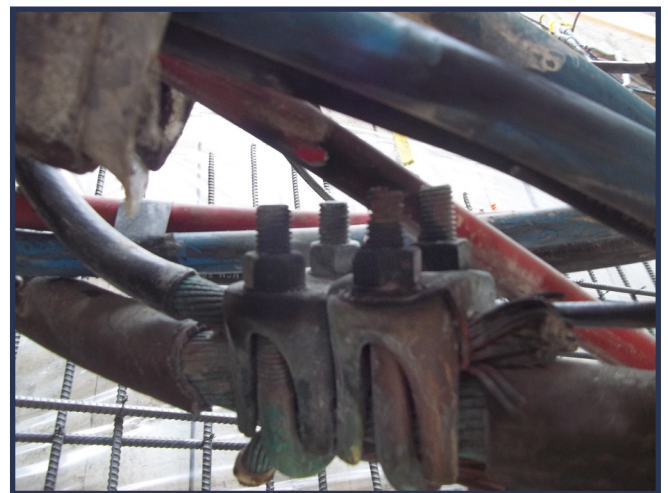
The bolts holding the grounds were facing up.
