# ToolboxTalk

## Shoring Box Collapse

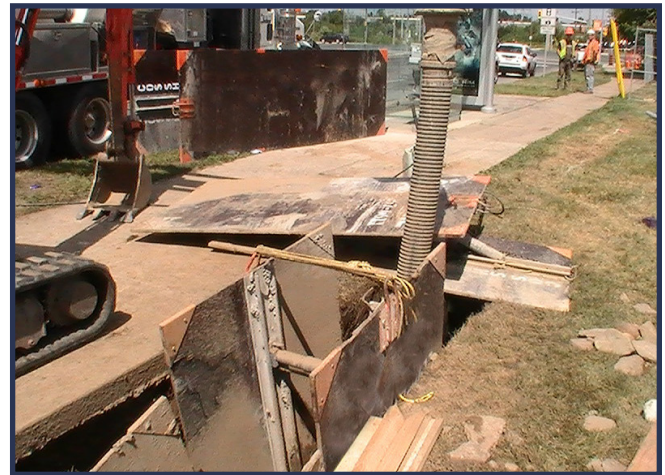
A worker was knocked over by a falling 8' x 4' Speed Shore shoring box.

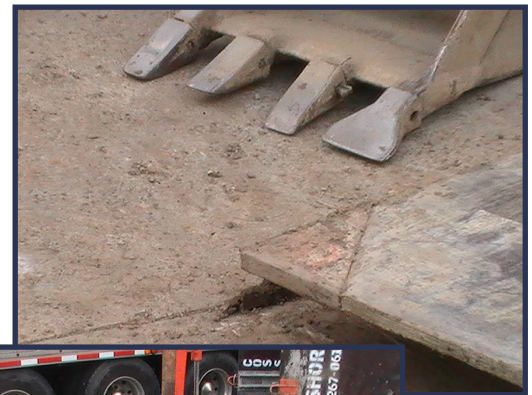
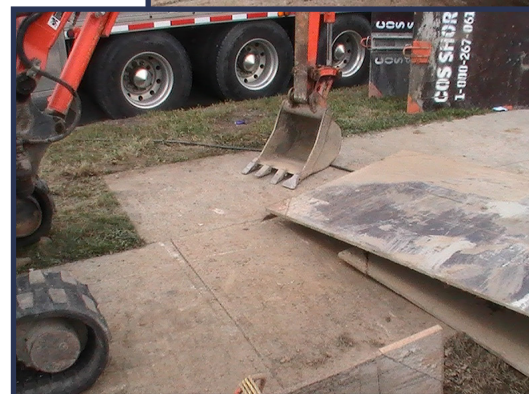
The shoring box had just been raised from a trench to excavate a little deeper. A Kubota U35 was used to hoist the shoring box out of the trench. A four-way lifting chain was used with a lifting ring hooked over the wide tooth of the excavator bucket. The shoring box was lifted out of the trench with the 8' length straight up and down. Once the shoring box had been lifted clear of the trench and set on the sidewalk adjacent to the trench, the lifting ring slipped from the tooth of the excavator allowing the box to collapse towards a worker, contacting him and pushing him back from the excavation. A second worker received scrapes on the forearms from the falling box while the foreman attempted to slow the descent of the box.

Teeth are not an appropriate attachment point for rigging hoists. Approved lifting points are to be used with appropriate lifting devices. In this case, a backhoe was on the site but was not used as it is not as easy to use as the mini-excavator.

If the lifting point had been attached to the backhoe through the lifting eye, the box would not have been capable of collapsing and falling.
