ToolboxTalk

Shoring Box Collapse

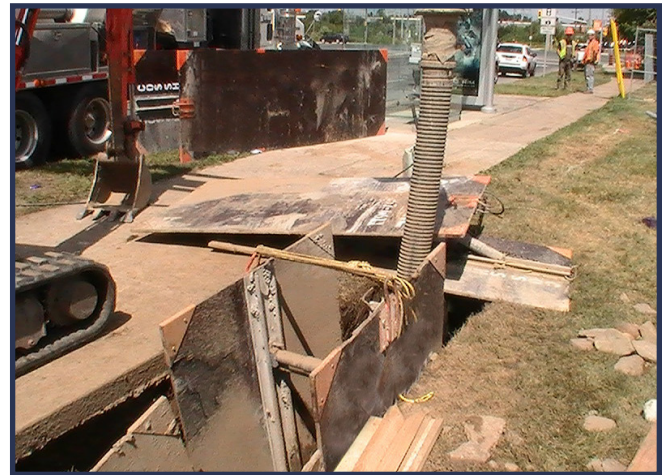
A worker was knocked over by a falling 8' x 4' Speed Shore shoring box.

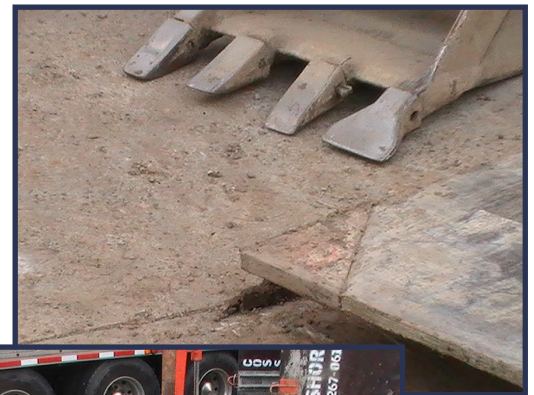
The shoring box had just been raised from a trench to excavate a little deeper. A Kubota U35 was used to hoist the shoring box out of the trench. A four-way lifting chain was used with a lifting ring hooked over the wide tooth of the excavator bucket. The shoring box was lifted out of the trench with the 8' length straight up and down. Once the shoring box had been lifted clear of the trench and set on the sidewalk adjacent to the trench, the lifting ring slipped from the tooth of the excavator allowing the box to collapse towards a worker, contacting him and pushing him back from the excavation. A second worker received scrapes on the forearms from the falling box while the foreman attempted to slow the descent of the box.

Teeth are not an appropriate attachment point for rigging hoists. Approved lifting points are to be used with appropriate lifting devices. In this case, a backhoe was on the site but was not used as it is not as easy to use as the mini-excavator.

If the lifting point had been attached to the backhoe through the lifting eye, the box would not have been capable of collapsing and falling.
